# **Evidence of soil instability and erosion along paths and roads in five villages in Central Ghana**

CRES/QA/EROSION/1/0401/1.1

**Report on visit 4-9 February 2001**

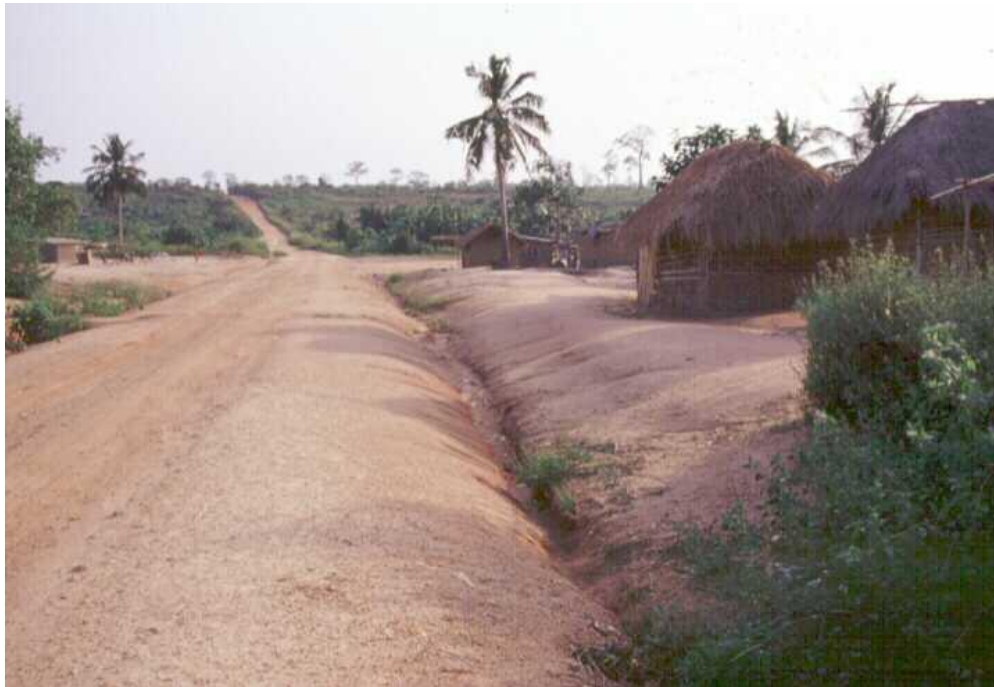
The road to the market in Awutu Bereku is 7.4 km in length, and was re-graded in November-December 1999 (Kathrin Blaufuss / Frank Owusu Acheampong, pers comm.). The sand-gravel surface (saprolite) of the road appears to have a silty matrix. This made-surface is at least 0.3 m in depth in places. There is evidence of granite cobbles in the road foundation. The road surface has good camber for drainage, and cut channels for drainage on either side. There is no evidence of breakout or extensive downcutting of these channels, except at a few localised places. Notable exceptions are the road-side channels within the Abora village itself (Figure 5). There is evidence that these channels were recently active. On the Eastern side of the village, there is evidence that field drainage coalesces into small gullies that drain into the road-side channels. To the South of the village (towards Awutu Bereku), the road passes through a valley and then rises steeply up the other side (Figure 5). A shallow, but long gully has developed within this steep road section (Figure 6), and appears to be feeding sediment directly to a pond in the valley, on the upstream side of the road (Figure 7). This pond, one of the water-supplies for Abora village (Blaufuss, pers. comm.), is very turbid. Other steep ( $>20^\circ$ ) sections of the 7.4 km road to Awutu Bereku have similar shallow gullies developed on their surfaces. Note: The middle section of this road is only shown as a path on the 1:50,000 scale map (sheet 0501A4) published in 1975.

**Figure 5. Road-side drain over-deepening due to surficial erosion, Adabra village looking South.**

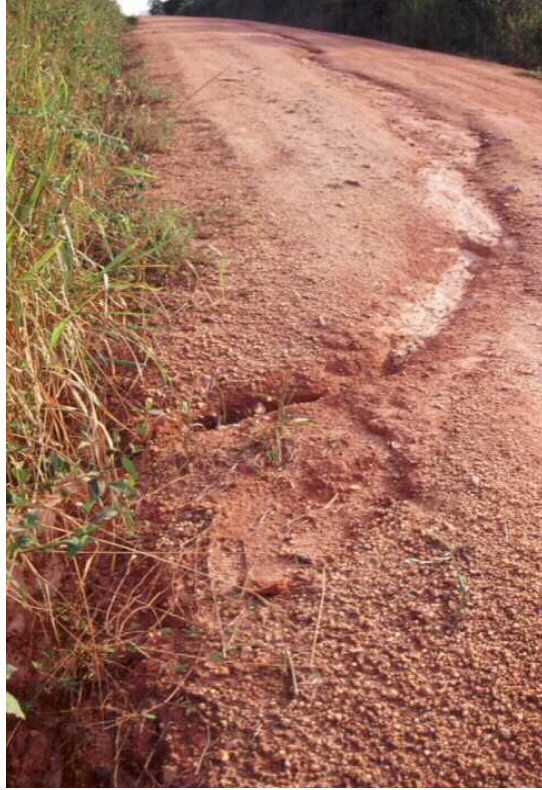
**Figure 6. Road gully developed on the slope on the far slope in Figure 5, Adabra village**

The paths seem relatively stable and capable of being widened for IMT use. Significant IMT damage to these paths is not expected. A few short sections of the feeder road to Awutu Bereku market are relatively steep and may develop gullies over the next few 'wet seasons'. These short sections may add to the effort of transport, but would probably not make the road impassable for IMTs for several years.

Monitor the rate of development of the gully on the feeder road just South of Adabra (Figure 6). Identify the presence of extreme rainfalls in the daily records over the next 12-15 months. Such events would be the most likely cause of any accelerated gully development (Douglas *et al.*, 1999). Use the monitored development of this gully as a semi-quantitative measure of the likely rate of deterioration of other steep road sections along the Adabra-Awutu Bereku feeder road.

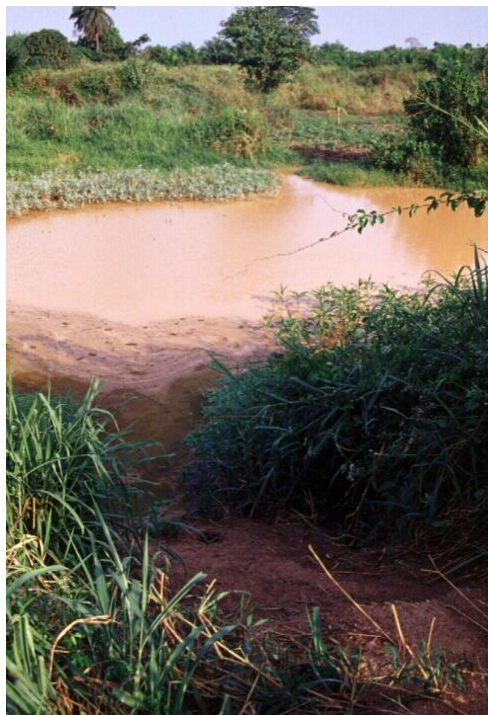
**Figure 7. Turbid pond partly sourced by the road gully shown in Figure 6, Adabra village**

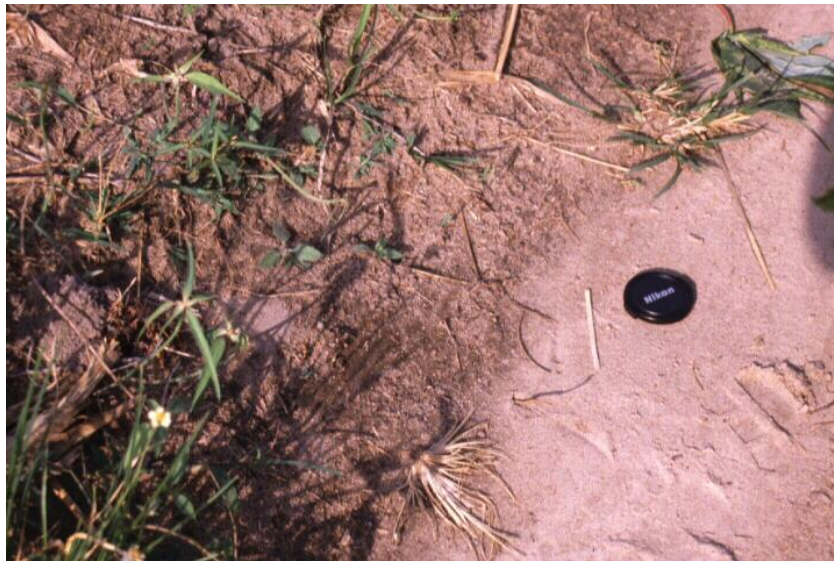
Path 1, which runs West of Adabra towards Okotokwa (Figure 4), is 0.3-0.5 m wide and is covered by sand-textured material (predominantly quartz from weathered granite) (Figure 8). This is no evidence of significant gullying or stream crossings along the first +600 m walked. One section has a depth of loose sand, which may pose difficulties for walking or IMTs, otherwise paths have a compact subsoil. Slopes are relatively shallow ( $<10^\circ$ ), so widening for IMT use should not pose additional 'cut-and-fill' instability problems (Figure 9). There is no evidence of significant gullying in surrounding fields, though some localised slope-wash may be present. Soils by the path appear sandy, but dark, probably as a result of high levels of organic matter (a positive soil binding agent). The soils around Adabra are mapped as Lixisols (locally 'Adawso-Bawjiai / Nta-Ofin Association'; Adu and Asiamah, 1992). Such soils have a higher base saturation than Acrisols, such as those found at Abora, Sampa, Lome and Awurabo, and as a result are expected to have less erodible soil structures (Deckers *et al.*, 1998), though surface slaking can make them prone to local slope-wash (Driessen and Dudal, 1991).

**Figure 8. Loose sand surface of path 1, Adabra village**

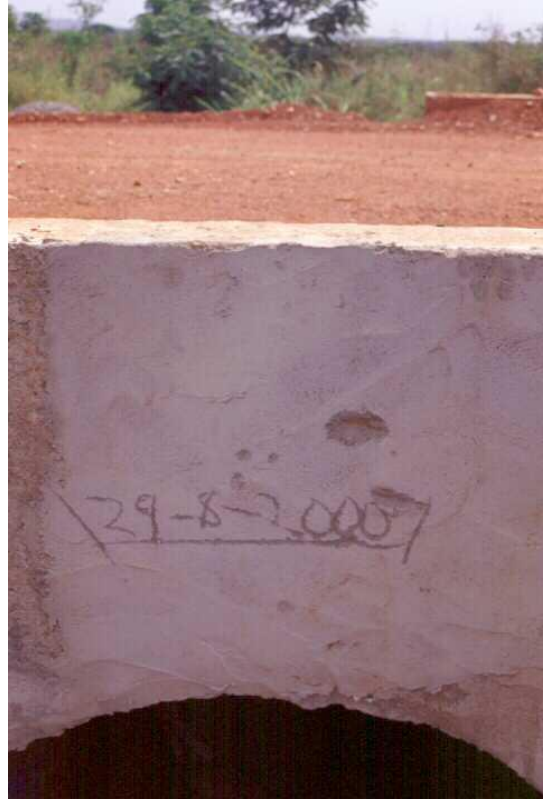
The feeder road connecting Abora village with the market (and source of water) at Ankamu settlement was re-graded in 1997, some culverts were repaired in 2000 (Figure 11), and a section close to Ankamu tarred in early 2001 (Kathrin Blaufuss / Frank Owusu Acheampong, pers comm.).

**Figure 11. A road culvert along the new Abora-Ankamu feeder road**

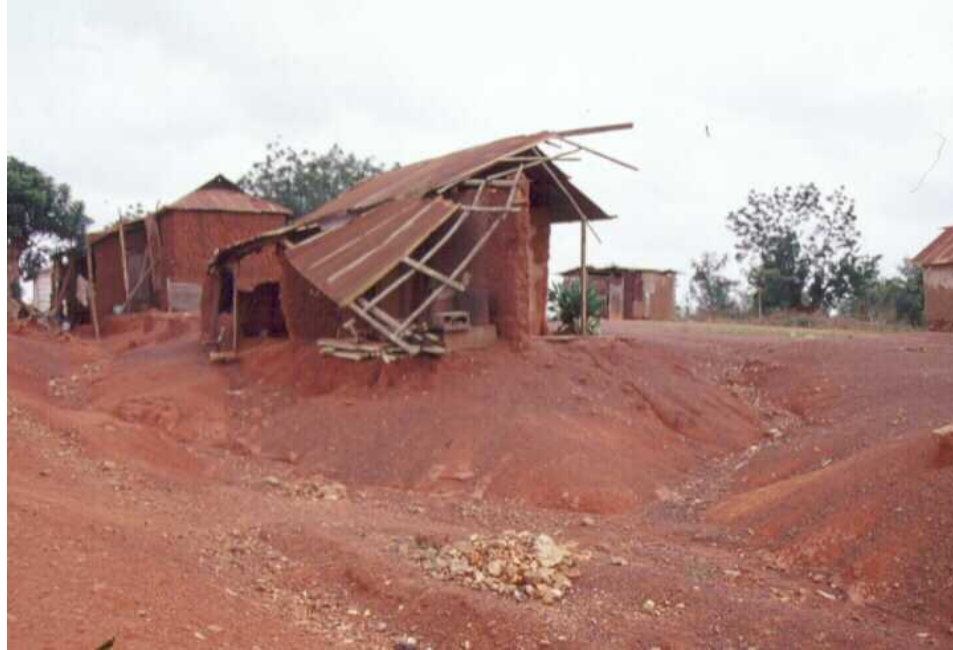
The likelihood of erosion of the road surface cannot be judged directly, as the road probably has not experienced many large storms since construction. The high rate of localised gullyng of the steeper slope of the Eastern part of Abora village (Figure 12), may, however, suggest that the local soils are relatively weak, so that gullyng may develop on the steep section of the Abora-Ankamu road, immediately North of Abora. The soils in the immediate vicinity of Abora are mapped as Acrisols (locally 'Bekwai-Nzima / Oda Association'; Asamoah, 1968), the dominant soil of Ghana / Ivory Coast region (Driessen and Dudal, 1991). Such soils are known to be susceptible to erosion, but not as weak as the related Alisols, which are rich in 2:1 clay minerals (Driessen and Dudal, 1991).

**Figure 12. Extensive gulying on the Eastern section of Abora village**

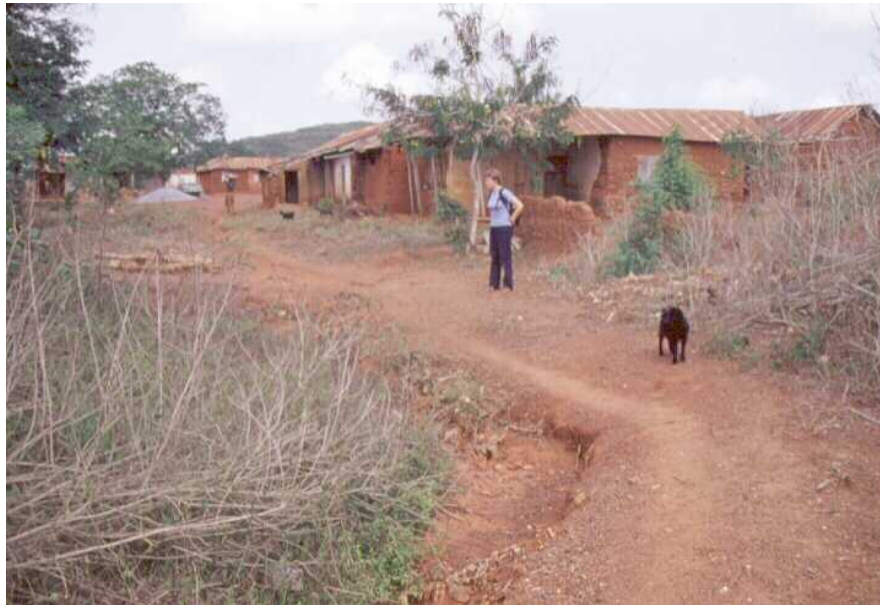
Path 1 connects Abora village with fields and with the market at Apam town, some 4.4 km away in a Southeasterly direction (Figure 10). The first 2 km of this path was examined. The start of this path has a small gully (up to 0.4 m deep and 0.4 m wide; Figure 13).

**Figure 13. A gully (centre foreground) developed at the start of path 1, Abora village**

This gully appears to be fed by the road-side channel East of the new Abora-Ankamu road, and by other gullies running through the Eastern half of Abora village (Figure 12). This gully, probably within Acrisol soils, is likely to offer a significant obstacle to IMT passage. The concentration of surface runoff in this area may also mean that the IMTs have a negative impact on the path surface in this area. The MOFA Village Infrastructure Project (VIP) is to make significant improvements to this footpath in the year 2001 (Thomas K Anang Siaw and Patrick A Larbi, pers. comm.; Siaw, 2000), and so is likely to remedy this local problem. Further along the path, the track lies within a small depression (0.05-0.10 m deep, 0.3 m wide) with a sandy-gravelly surface. There is flat terrain either side of the path, so widening for IMT use should not require any slope cutting. There is one small area of the path where the soil is wet, and probably relates to a small stream crossing the path. I suspect that this would be easily culverted during the VIP path improvements. At approximately 1.5 km from Abora, there is a very flat area (perhaps a shallow depression, Figure 14), with very dark brown soils, that exhibit strong cracking (Figure 15).

Local gully development and soft ground along Path 1 would probably give problems for IMT use during the wet seasons. This path is, however, to be improved in 2001 as part of the Village Infrastructure Project. The key issue, therefore, is the success of the engineered earthworks in overcoming the local soil problems. If extreme storms ( $> 100 \text{ mm d}^{-1}$ ) occur over the next 12-15 months, gullies may develop in the feeder roads close to the village due to the intrinsic weakness of the local materials. Such gullies may hinder IMT use along short sections of the Abora-Ankamu road.

Monitor the engineering works on Path 1, particularly how the surface runoff at (a) the start of the path, and (b) within the Vertisol area, is managed. Note any gullies that develop in the new feeder road.

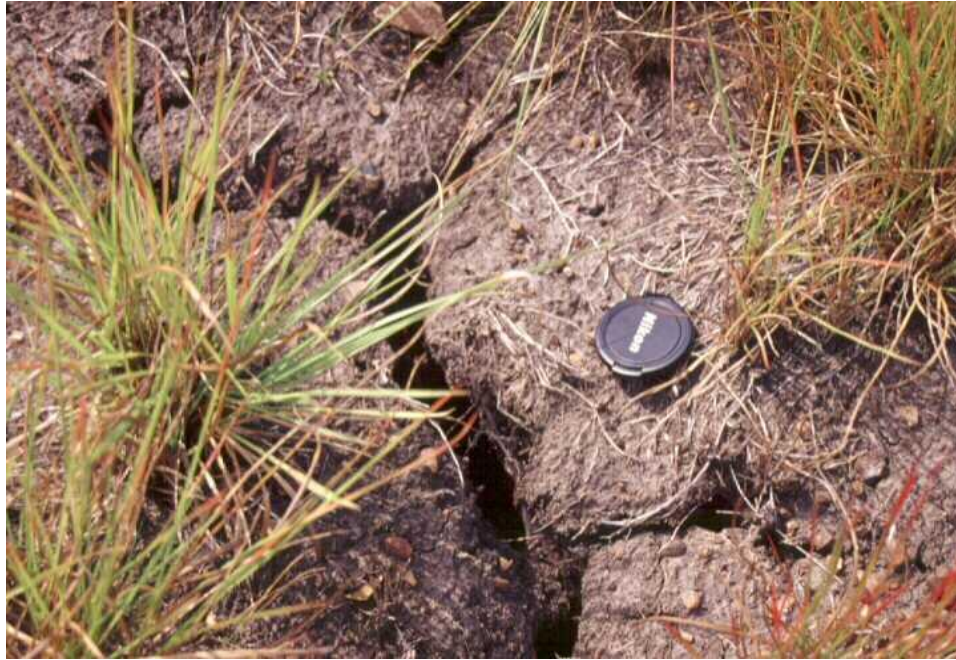
The dry-season cracking probably indicates the presence of expanding 2:1 lattice clays. These soils are mapped as Vertisol soils (locally 'Osibi-Bumbi Association'; Asamoah, 1968). While there is no evidence of old ruts associated with damage during the wet season, Vertisol soils are likely to become very slippery and waterlogged during the rainy season (once the peds have swollen with the first rains). An elevated causeway (made

**Figure 15. Cracks within the Vertisol soils along Path 1, Southeast of Abora village**

from soils other than Vertisols) with subsurface drainage may be necessary for successful IMT use during the wet-season. Such a causeway is planned with the VIP improvements.

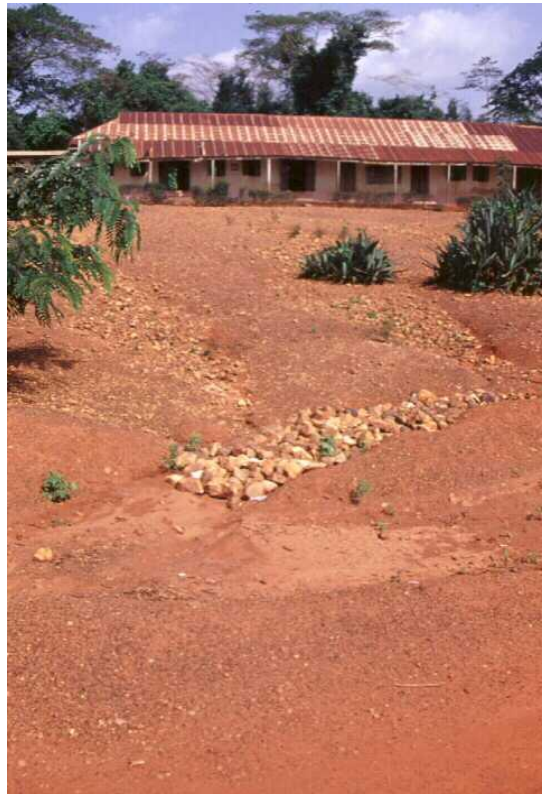
The road from Akropon to Brofo village passes through Sampa. This road is in a very good condition, probably as a result of the re-grading in May-June 1998 (Kathrin Blaufuss / Frank Owusu Acheampong, pers comm.). On the very steep section of this road immediately North of Sampa, the Western road-side drainage channel has over-deepened slightly and exposed the underlying bedrock. During extreme rainfall events (e.g., 1 in 5 year recurrence interval) of the wet-seasons, gullying is likely on such steep sections of feeder roads. Along the road to the South of Sampa, several concrete culverts (one dated 1976) were seen to be in good condition. Gully protection works were seen in the grounds of the village school. Cobbles had been placed in gullies to arrest their development (Figure 17).

**Figure 17. Gully control using rock dams, school grounds, Sampa village**

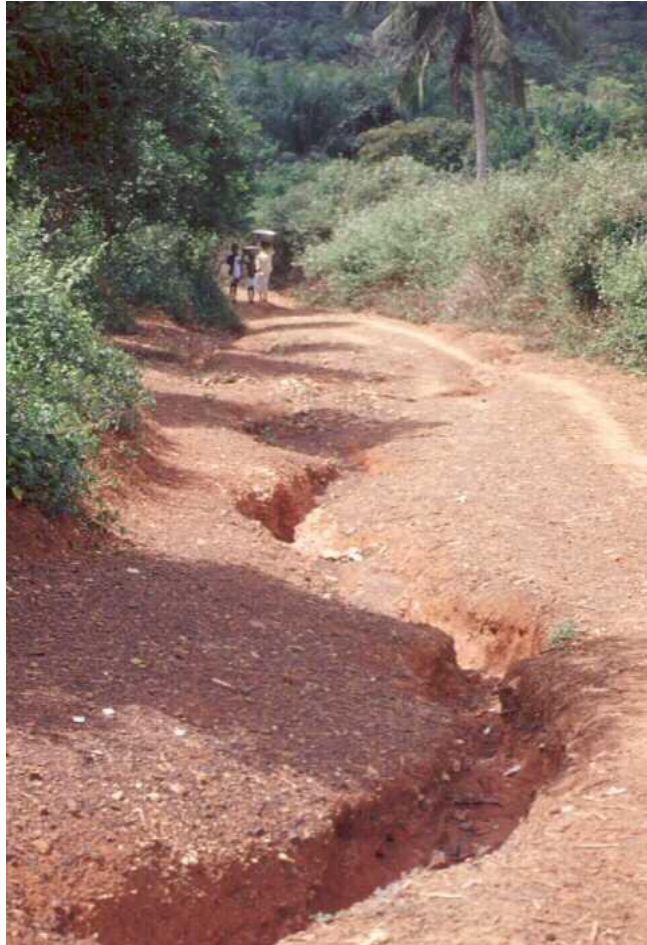
gully in excess of 100 m in length (Figure 18), and fed probably by surface flow generated in the Northwestern corner of the village. Sampa lies within the same region of relatively weak Acrisol soils as at Abora (locally 'Bekwai-Nzima / Oda Association'; Asamoah, 1968).

**Figure 18. Gully development at the start of path 1, the route to the River Okye (Sampa village)**

With further development, this gully would affect the passage of IMTs (see Figure 19), though I suspect that the steepness of the slope makes IMT use already hard work on this section of the Sampa-Okya River path. Below this steep section, the path has a modest gradient and is already wide enough for the use of IMTs. The soils are very dry (< 20 % moisture content by volume), with the exception of one flat area half way to the R. Okya (by the plantain plot). The wetness of the soils in this area allowed estimation of the particle texture, which appeared to be a loam. By the River Okya, the soils were, however, sandy (probably alluvial sands).

The paths seem relatively stable and capable of supporting the IMTs, with the possible exception of the very steep section of Path 1, as it leaves Sampa. Indeed, the IMTs may exacerbate the gully development if soil conservation measures are not undertaken. The feeder road in this locality appears relatively stable.

Monitor the growth of the gully at the start of Path 1, and any soil conservation measures undertaken to maintain trafficability.

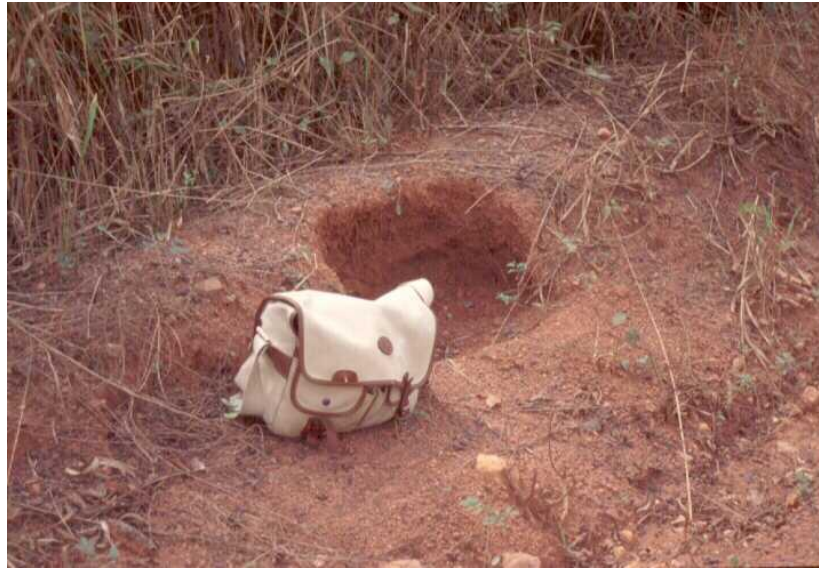
The feeder road from Lome to Dawurampon town had a very uneven surface in places, indicative of the presence of ruts and very poor trafficability during wet seasons. This road had been re-graded in November-December 1999 (Kathrin Blaufuss / Frank Owusu Acheampong, pers comm.). Close to the village, the road appeared to be in a better condition. This may have been because of the relatively modest slopes, or to small-scale repairs undertaken by the villagers themselves (Figure 21).

**Figure 21. A small borrow pit (?), used to repair small road gullies, Lome village**

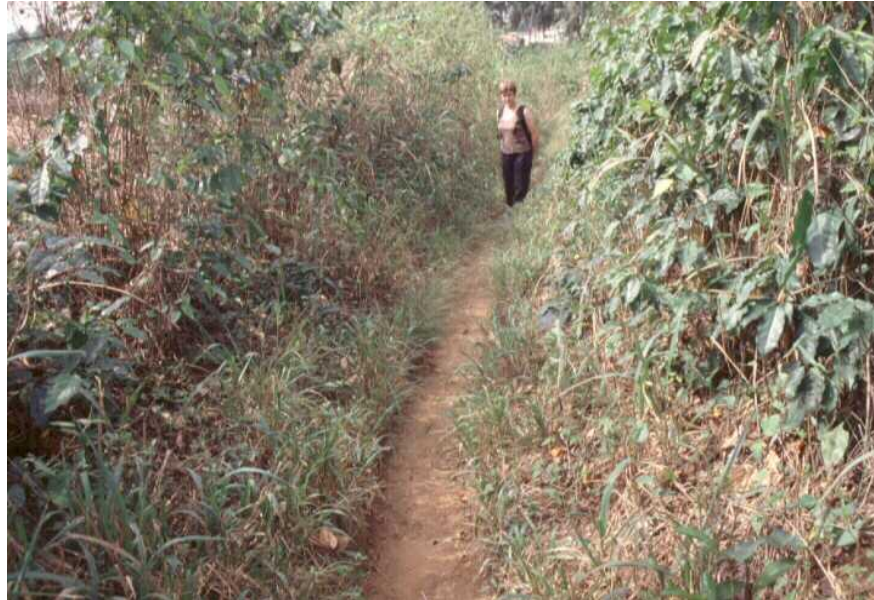
Path 1 (not shown on Figure 20) is used by the villagers to access fields directly East of Lome, and heads into the Yenku Block A Forest Reserve. The path traverses a very undulating topography, is very narrow and has steep banks either side (Figure 22). Much excavation would be required to widen the path for the use of the 'push-truck' IMTs (Figure 15). There is evidence of some localised gully erosion in the granitic soils on the steeper slope elements. The soil in this region is mapped as a relatively weak Acrisol (locally 'Abonku-Eja / Awuaya-Nkansaku; Asamoah, 1968). The locally steep slopes, heavy pedestrian use of Path 1 (Blaufuss pers. comm.; Porter, 1999) and the Acrisol soil readily explain the presence of gullying.

**Figure 22. Path 1 (between Lome village and the Yenku Block A Forest Reserve). The narrowness of the path and steep banks either side should be noted**

The incised nature of Path 1 would make widening for IMT use a significant task. Furthermore, the high local relief may mean that IMT use significantly increases soil mobilisation. Existing pedestrian traffic, as well as new IMT traffic, may be negatively affected by the use of wheeled vehicles. The other paths do not seem to suffer from the same risks. Evidence from old ruts indicates that IMT use along the Dawurampon road may become difficult during wet seasons.

Record any earthworks activity along Path 1 undertaken for IMT use. Record use of IMTs along the Dawurampon feeder road; when present, note the date and location of any trafficability problems.

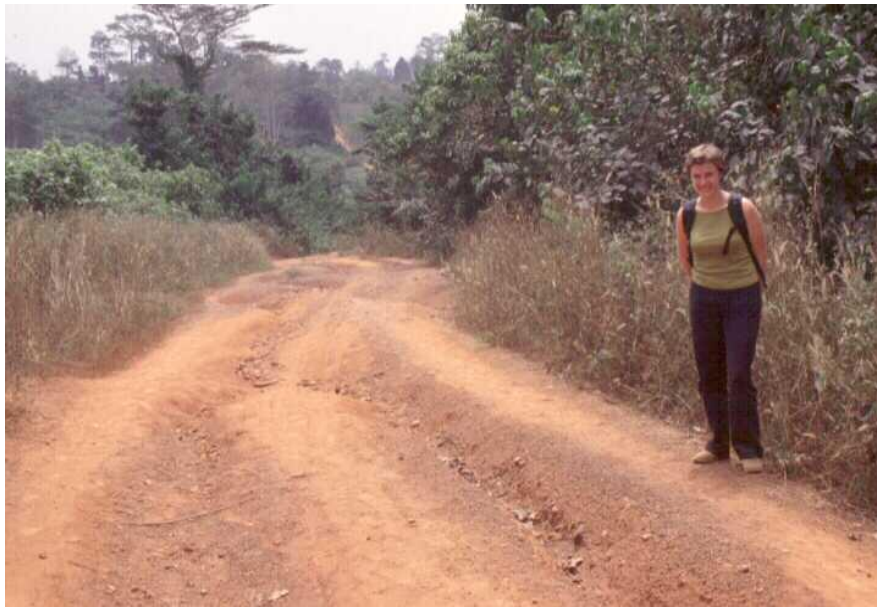
Neither the feeder roads or the village itself are shown on the 1:50,000 map (sheet 0502B2) produced in 1974/5. In places the local feeder roads have a very uneven surface indicating severe trafficability problems during wet seasons. Mud has been splashed to great heights onto the road-side vegetation, probably indicting heavy use of the road by lorries (perhaps transporting the cocoa). The road East of Awurabo (towards 'Japan Bridge') had been re-graded in June 2000 (Kathrin Blaufuss / Frank Owusu Acheampong, pers comm.). The distances from Awurabo village East to the market at Assin Akonfonde (via 'Japan Bridge') or South to the market at Assin Akropon are both in excess of 10 km, the latter feeder road being particularly gullied (Figure 24).

**Figure 24. A heavily gullied section of feeder road near to Awurabo village**

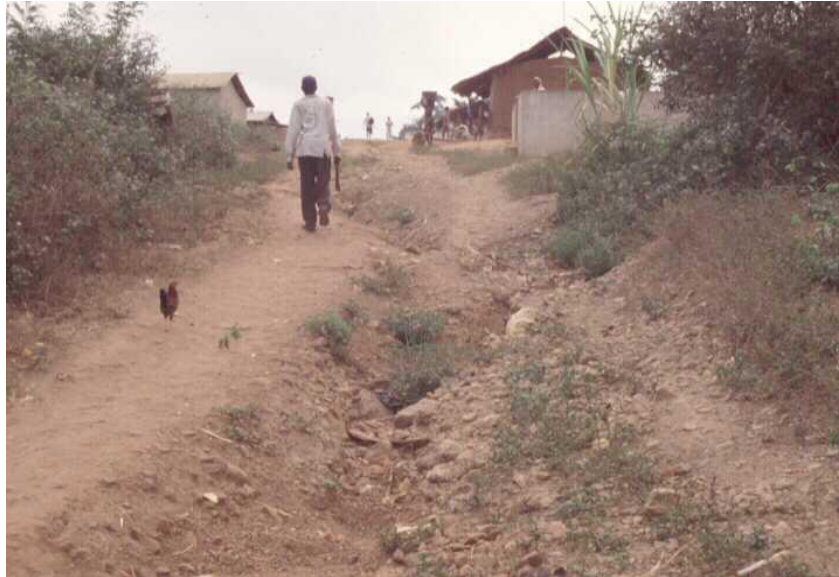
Path 1 leads from Awurabo in the Southwesterly direction towards 'Japan Bridge'. The first section of this path is gullied, and rocks have been used to attempt to check the development (Figure 25). Further along the path, there is evidence that a tracked-vehicle had been used to widen the path (undertaken during July-August 2000; Kathrin Blaufuss / Frank Owusu Acheampong, pers comm.). The undulating surface of this track indicates some local instability / erosion (Figure 24). Awurabo is within an area mapped as Acrisol (locally 'Nsaba-Swedru / Nta-Ofin Association'; Asamoah, 1968). The presence of cracking may indicate the presence of unstable clays (Figure 26) and hence the possibility that these soils may be a more erodible Acrisol-Alisol intergrade (Driessen and Dudal, 1991). The Alisol classification has only been identified since 1988; such soils were formerly classified with the more stable members of the old Acrisol group. Local cation

**Figure 25. Gully at the start of path 1, Awurabo village. Some gully control may have been undertaken with rock placement.**

Development of the gully at the start of Path 1 may make IMT use difficult, as may further deterioration of a latter section of the same path that was affected by a tracked vehicle. Path 1 may be sensitive to IMT damage during wet seasons and should be monitored. The streams and narrow bridges along Path 2 and 3 may inhibit the use of IMTs for transporting produce from distant fields.

Observe the development of the gully at the start of Path 1, and record any repairs (soil conservation measures). Observe if the tracked-vehicle damage to Path 1 further deteriorates or stabilises.

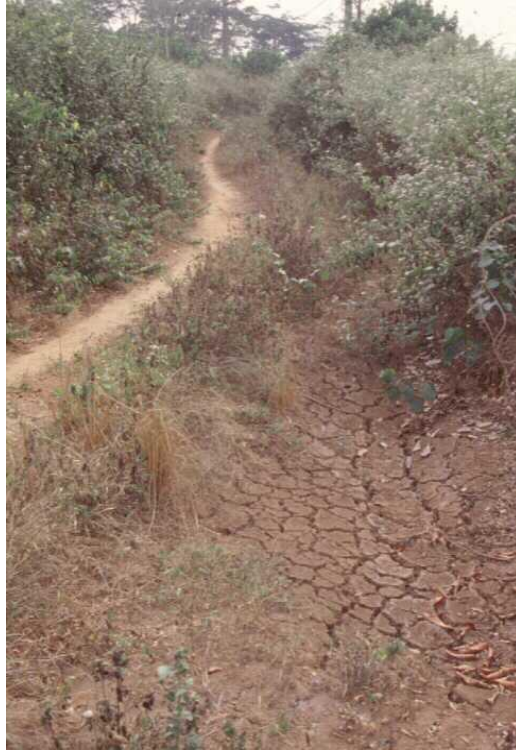
**Figure 26. A section of Path 1 (Awurabo village) widened by a tracked vehicle, showing signs of swelling clays (i.e., instability) and gullying**
