# **Evidence of soil instability and erosion along paths and roads in five villages in Central Ghana**

CRES/QA/EROSION/1/0401/1.1

**Report on visit 4-9 February 2001**

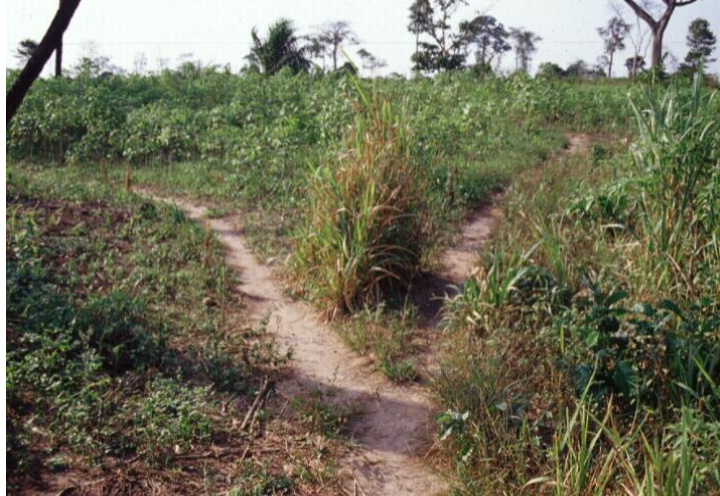
Path 1, which runs West of Adabra towards Okotokwa (Figure 4), is 0.3-0.5 m wide and is covered by sand-textured material (predominantly quartz from weathered granite) (Figure 8). This is no evidence of significant gullying or stream crossings along the first +600 m walked. One section has a depth of loose sand, which may pose difficulties for walking or IMTs, otherwise paths have a compact subsoil. Slopes are relatively shallow ( $<10^\circ$ ), so widening for IMT use should not pose additional 'cut-and-fill' instability problems (Figure 9). There is no evidence of significant gullying in surrounding fields, though some localised slope-wash may be present. Soils by the path appear sandy, but dark, probably as a result of high levels of organic matter (a positive soil binding agent). The soils around Adabra are mapped as Lixisols (locally 'Adawso-Bawjiai / Nta-Ofin Association'; Adu and Asiamah, 1992). Such soils have a higher base saturation than Acrisols, such as those found at Abora, Sampa, Lome and Awurabo, and as a result are expected to have less erodible soil structures (Deckers *et al.*, 1998), though surface slaking can make them prone to local slope-wash (Driessen and Dudal, 1991).

**Figure 9. Flat terrain about Path 1, Adabra village**

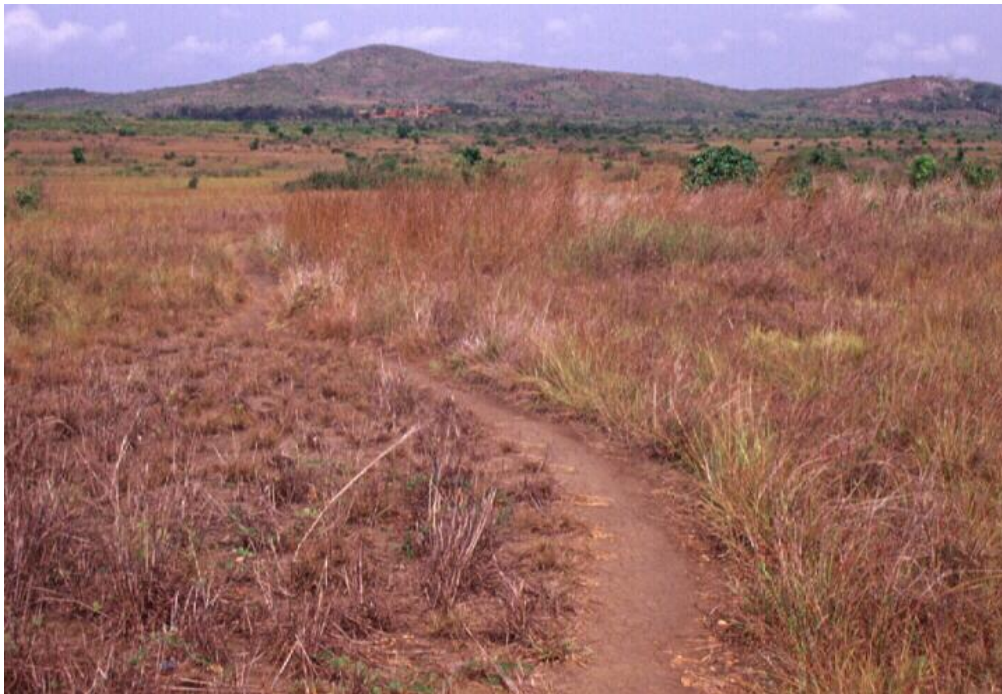
**Figure 14. Abora village is just below the peak of Abora Hill on the horizon. Photograph taken from the depression containing Vertisol soils.**

The dry-season cracking probably indicates the presence of expanding 2:1 lattice clays. These soils are mapped as Vertisol soils (locally 'Osibi-Bumbi Association'; Asamoah, 1968). While there is no evidence of old ruts associated with damage during the wet season, Vertisol soils are likely to become very slippery and waterlogged during the rainy season (once the peds have swollen with the first rains). An elevated causeway (made

from soils other than Vertisols) with subsurface drainage may be necessary for successful IMT use during the wet-season. Such a causeway is planned with the VIP improvements.

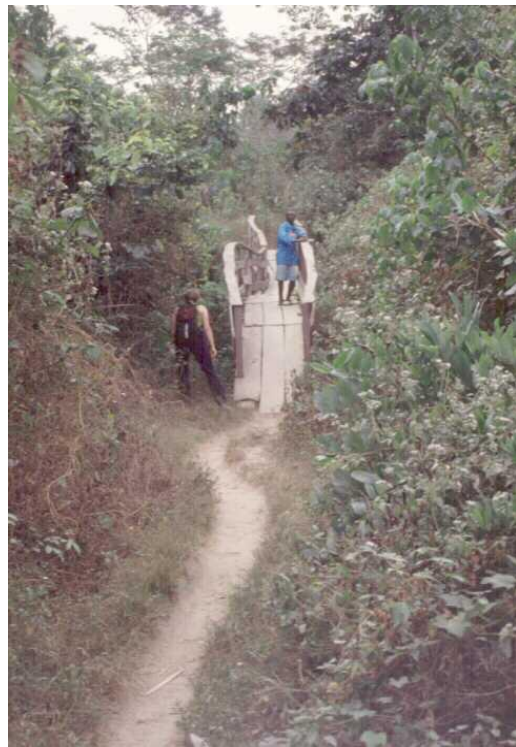
Path 2 leads in a South by Southwest direction towards a relatively large bridge constructed by the community (Figure 27). Path 3 starts from the same point on the Southern edge of Awurabo village as Path 2, but continues in Southerly direction towards (and beyond) a small bridge. Water is abstracted from these two bridge locations for most of the year. The terrain is relatively flat along course of Path 2 and 3, so there are little signs of erosion.

**Figure 27. The cedar bridge constructed by the community along Path 2, Awurabo village**
